Manhole Inspection Summary

Manhole # S57A__018MH

Insp Date: **7/28/08 11:33 AM**

Location Address: **4301 n janey st**

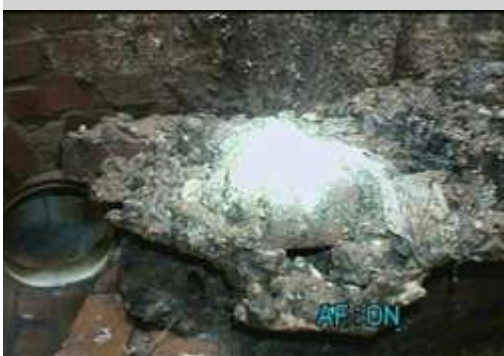
Defect 3

Condition: ☐ Sound ☐ Cracked ☐ Root Intrusion ☐ Deteriorated ☐ Leaks ☒ **Debris**

bench_debris , bench_cond debris

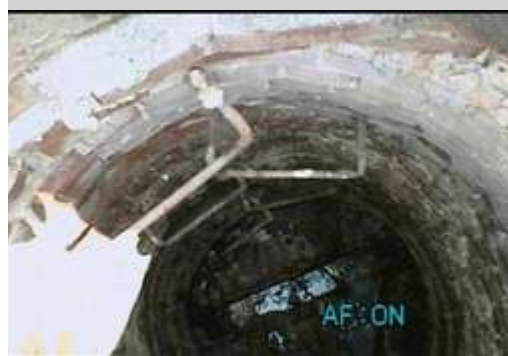
Defect 2

Count: **5** Missing: **0** ☒ **Corroded**

steps

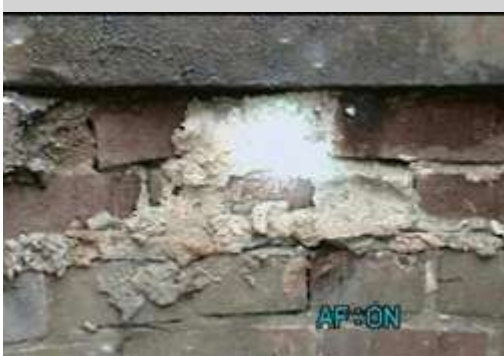
Defect 1

Condition: ☐ Sound ☐ Cracked ☐ Root Intrusion ☐ Loose Brick ☒ **Deteriorated**

chimney_cond_deteriorated

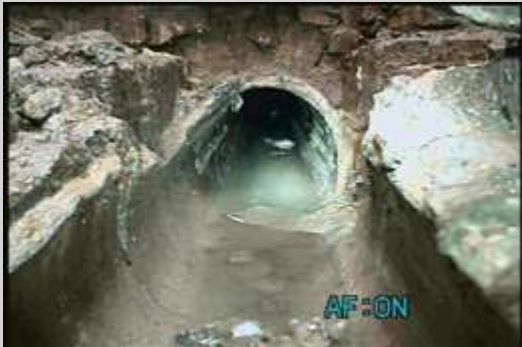
12 O'Clock Outflow

8 in. Circular Gravity Sewer
Pipe Out @ 12 O'Clock

Invert Depth: 9.75 (ft.) Flow Characteristics: Slow

Infiltration: None

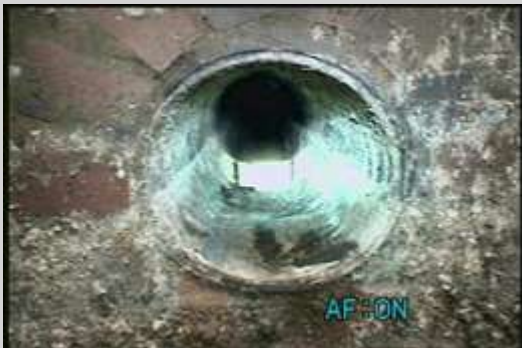
3 O'Clock Inflow

8 in. Circular Gravity Sewer
Pipe In @ 3 O'Clock

drop In @ 3 O'Clock

Drop: Outside Direct

Drop Condition: Open

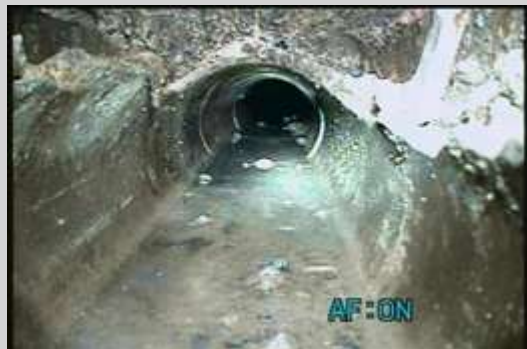
6 O'Clock Inflow

8 in. Circular Gravity Sewer
Pipe In @ 6 O'Clock

Invert Depth: **9.66** (ft.) Flow Characteristics: **Slow**

Infiltration: **None**
